NASA  
Technical Memorandum 4195

# Evaluation of Composite Components on the Bell 206L and Sikorsky S-76 Helicopters

Donald J. Baker

AUGUST 1990

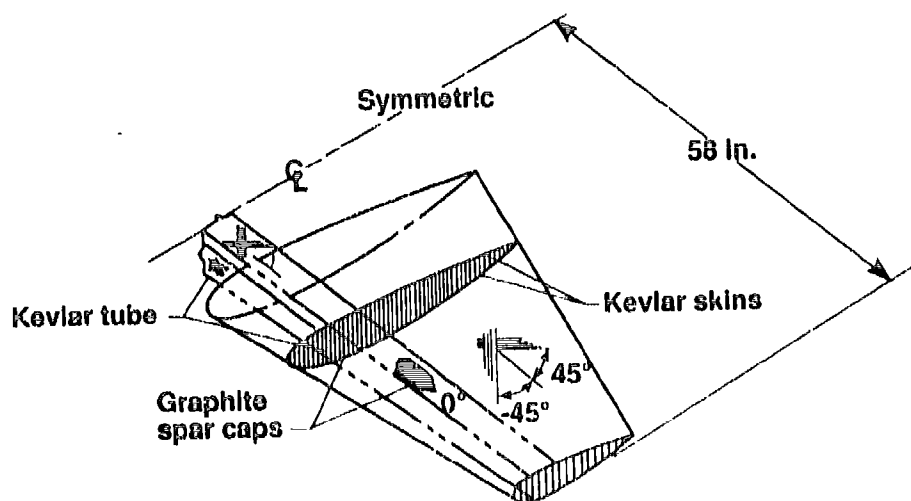
Figure 24. Composite stabilizer for the S-76.

**Horizontal stabilizer.** A sketch of the left half of the horizontal stabilizer is shown in figure 24. The stabilizer is a full-depth sandwich structure with cross-plyed Kevlar-49 fabric/5143<sup>13</sup> epoxy composite material skins and Nomex honeycomb core. The torque tube that joins the left and right sides of the stabilizer is full-depth aluminum honeycomb construction with unidirectional AS1<sup>14</sup> graphite/6350<sup>15</sup> epoxy composite material in the spar caps. The torque tube is overwrapped with cross-plyed Kevlar-49 fabric/5143 epoxy to provide additional torsional rigidity. The composite horizontal stabilizer weighs 40.0 lbm.

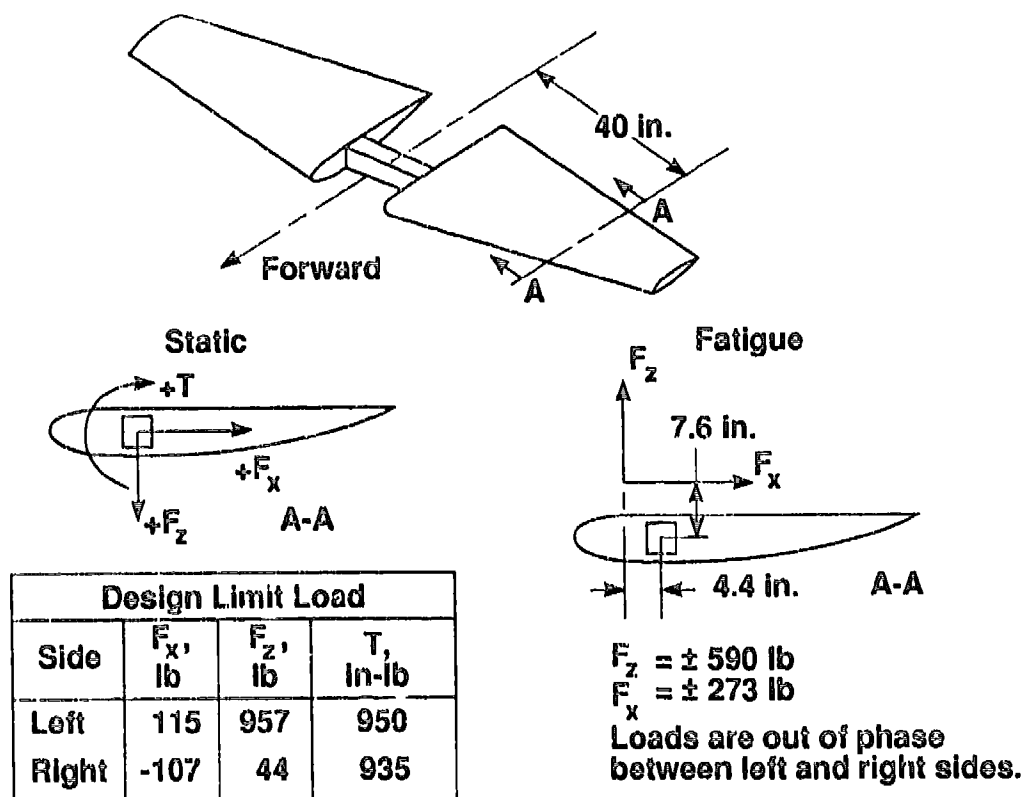
Figure 25. Load conditions for the S-76 horizontal stabilizer.

this stabilizer at proof load was the same as the corresponding deflection for the stabilizer used for the acceptance test. The same loads were applied for fatigue as were used for certification (fig. 25). After 437 340 cycles, fracture occurred in the torque box.

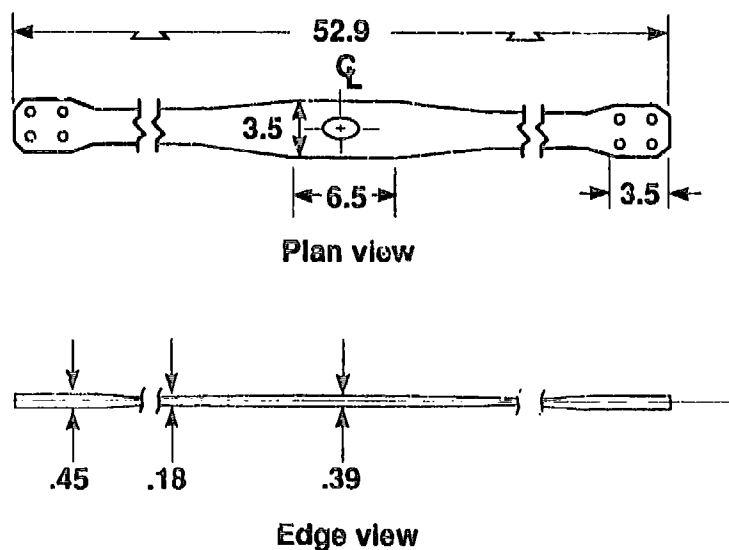
Figure 26. Composite tail rotor spar for the S-76. All dimensions are given in inches.

**Tail rotor spar.** The tail rotor spar is a solid laminate constructed with AS1 graphite/6350 epoxy composite material. The spar is 52.9 in. long by 3.5 in. wide and is shown in figure 26. The weight of the spar is 14.6 lbm. Two glass/epoxy blades are attached to the spar to form the tail rotor paddle as shown in figure 27.

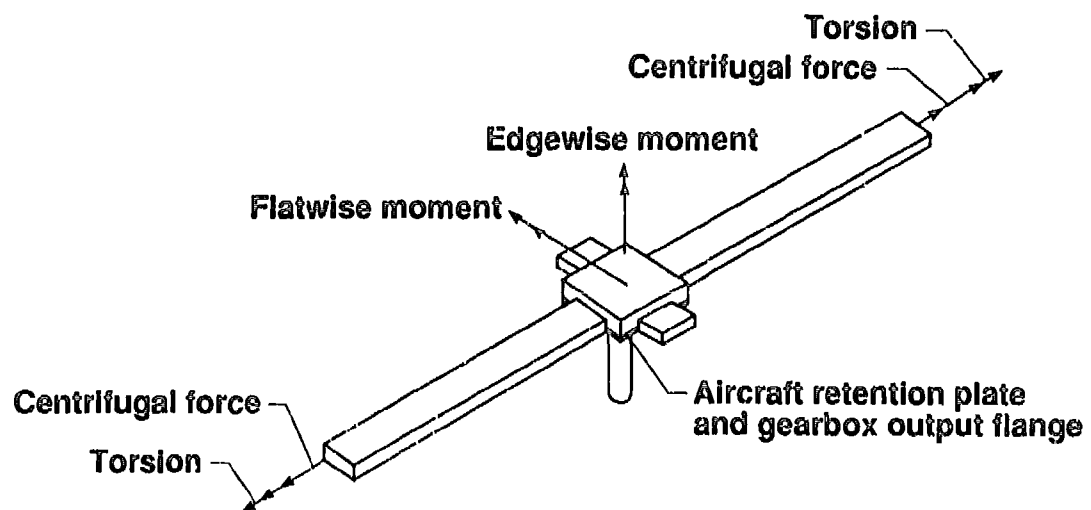
Figure 28. Schematic diagram of S-76 tail rotor spar loadings.

The tail rotor spar was designed to withstand a high number of cyclic loads. The tail rotor was fatigue tested using the edgewise moment, flatwise moment, torsion, and centrifugal loads illustrated in figure 28. The centrifugal load is kept constant and represents the centrifugal force for a rotor operating at 110 percent of the normal rotor speed. The cyclic loadings are in phase and are held in the same proportions as the absolute values are varied to produce a fatigue fracture in the range from  $10^5$  to  $5 \times 10^6$  cycles.

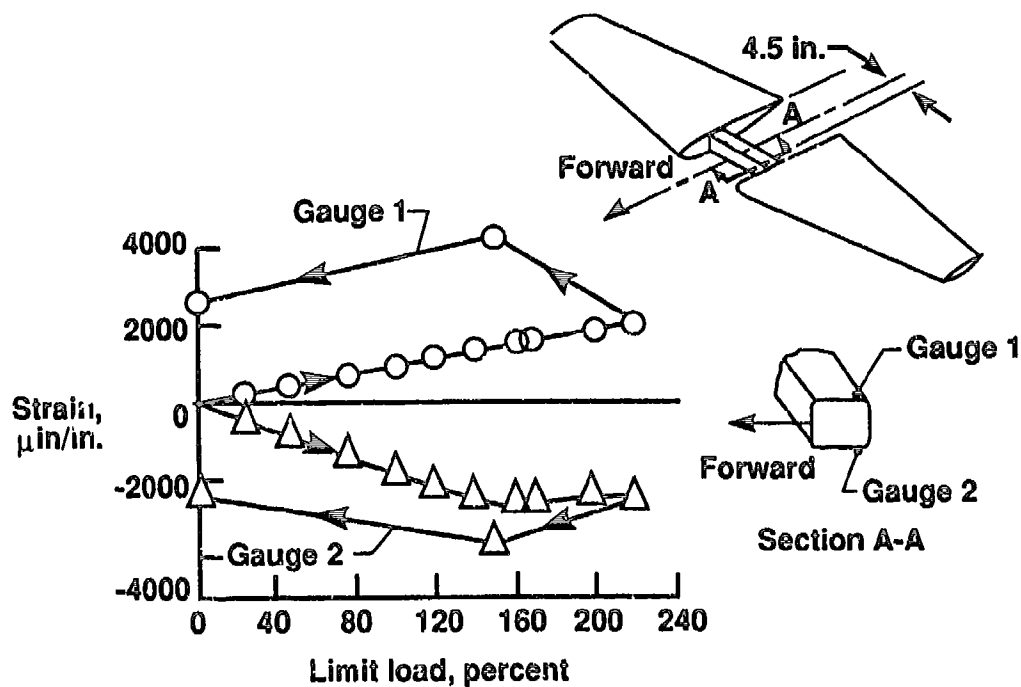
Figure 29. Strain as a function of limit load on the S-76 stabilizer.

a function of percent limit load are shown in figure 29. The tension strain response was linear up to 160 percent of the design limit load (DLL) and then increased at reduced slope until the maximum applied load of 220 percent of the DLL was reached. The compression strain response was linear to 120 percent of the DLL and then increased at a reduced slope until 170 percent of the DLL was reached. The compression strain did not increase after 170 percent of the DLL. At 220 percent of the DLL the stabilizer made a loud "snap" and the load dropped to 150 percent of the DLL. Attempts to increase the load beyond 150 percent of the DLL resulted in an increased deflection until the test fixture limit was reached. Visual inspection of the stabilizer indicated a buckle in the splice plate on the left-hand leading edge of the torque box. A teardown of the component revealed a loss of shear transfer capabilities between the composite material and the metal honeycomb. The stabilizer tested for certification did not fail but reached the maximum deflection allowed by the fixture at 268 percent of DLL.

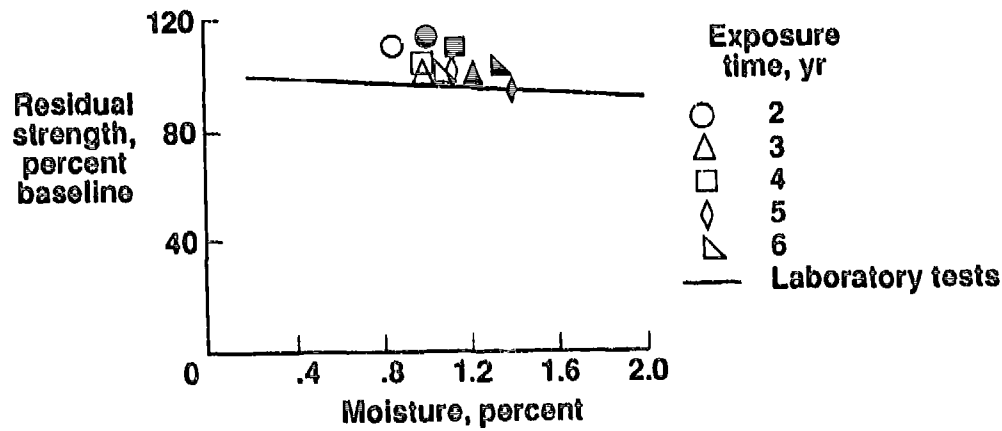
Figure 33. Effect of moisture on residual flexure strength of 6-ply AS1/6350 material. Open symbols represent Stratford, Connecticut; solid symbols represent West Palm Beach, Florida.

34, and 35, respectively. Each individual data point is the mean strength of 18 tests. The solid line in each figure is the residual strength after the accelerated conditioning of the specimens (ref. 4). Residual flexure strengths in figure 33 for exposed 6-ply AS1/6350 laminates exceed 95 percent of the baseline strength and also meet (5 years at West Palm Beach, Florida) or exceed the strength of the accelerated conditioned specimens. Residual short-beam shear strengths in figure 34 for exposed AS1/6350 laminates vary between 72 and 89 percent of baseline and are within 1 percent of the strength of the accelerated conditioned specimens. Residual tension strengths in figure 35 of the Kevlar-49/5143 material vary from 99 to 107 percent of the baseline strength and exceed the strength of the accelerated conditioned specimens by 11 to 24 percent. This material follows the same trend as the tension strength of Kevlar-49 fabric materials used in the Bell 206L program.
